# **Distribution Construction**

## **Inspection Findings**

New England Pipeline Safety Seminar  
October 20, 2010

Karl Baker – CT DPUC  
Gary Kenny – ME PUC

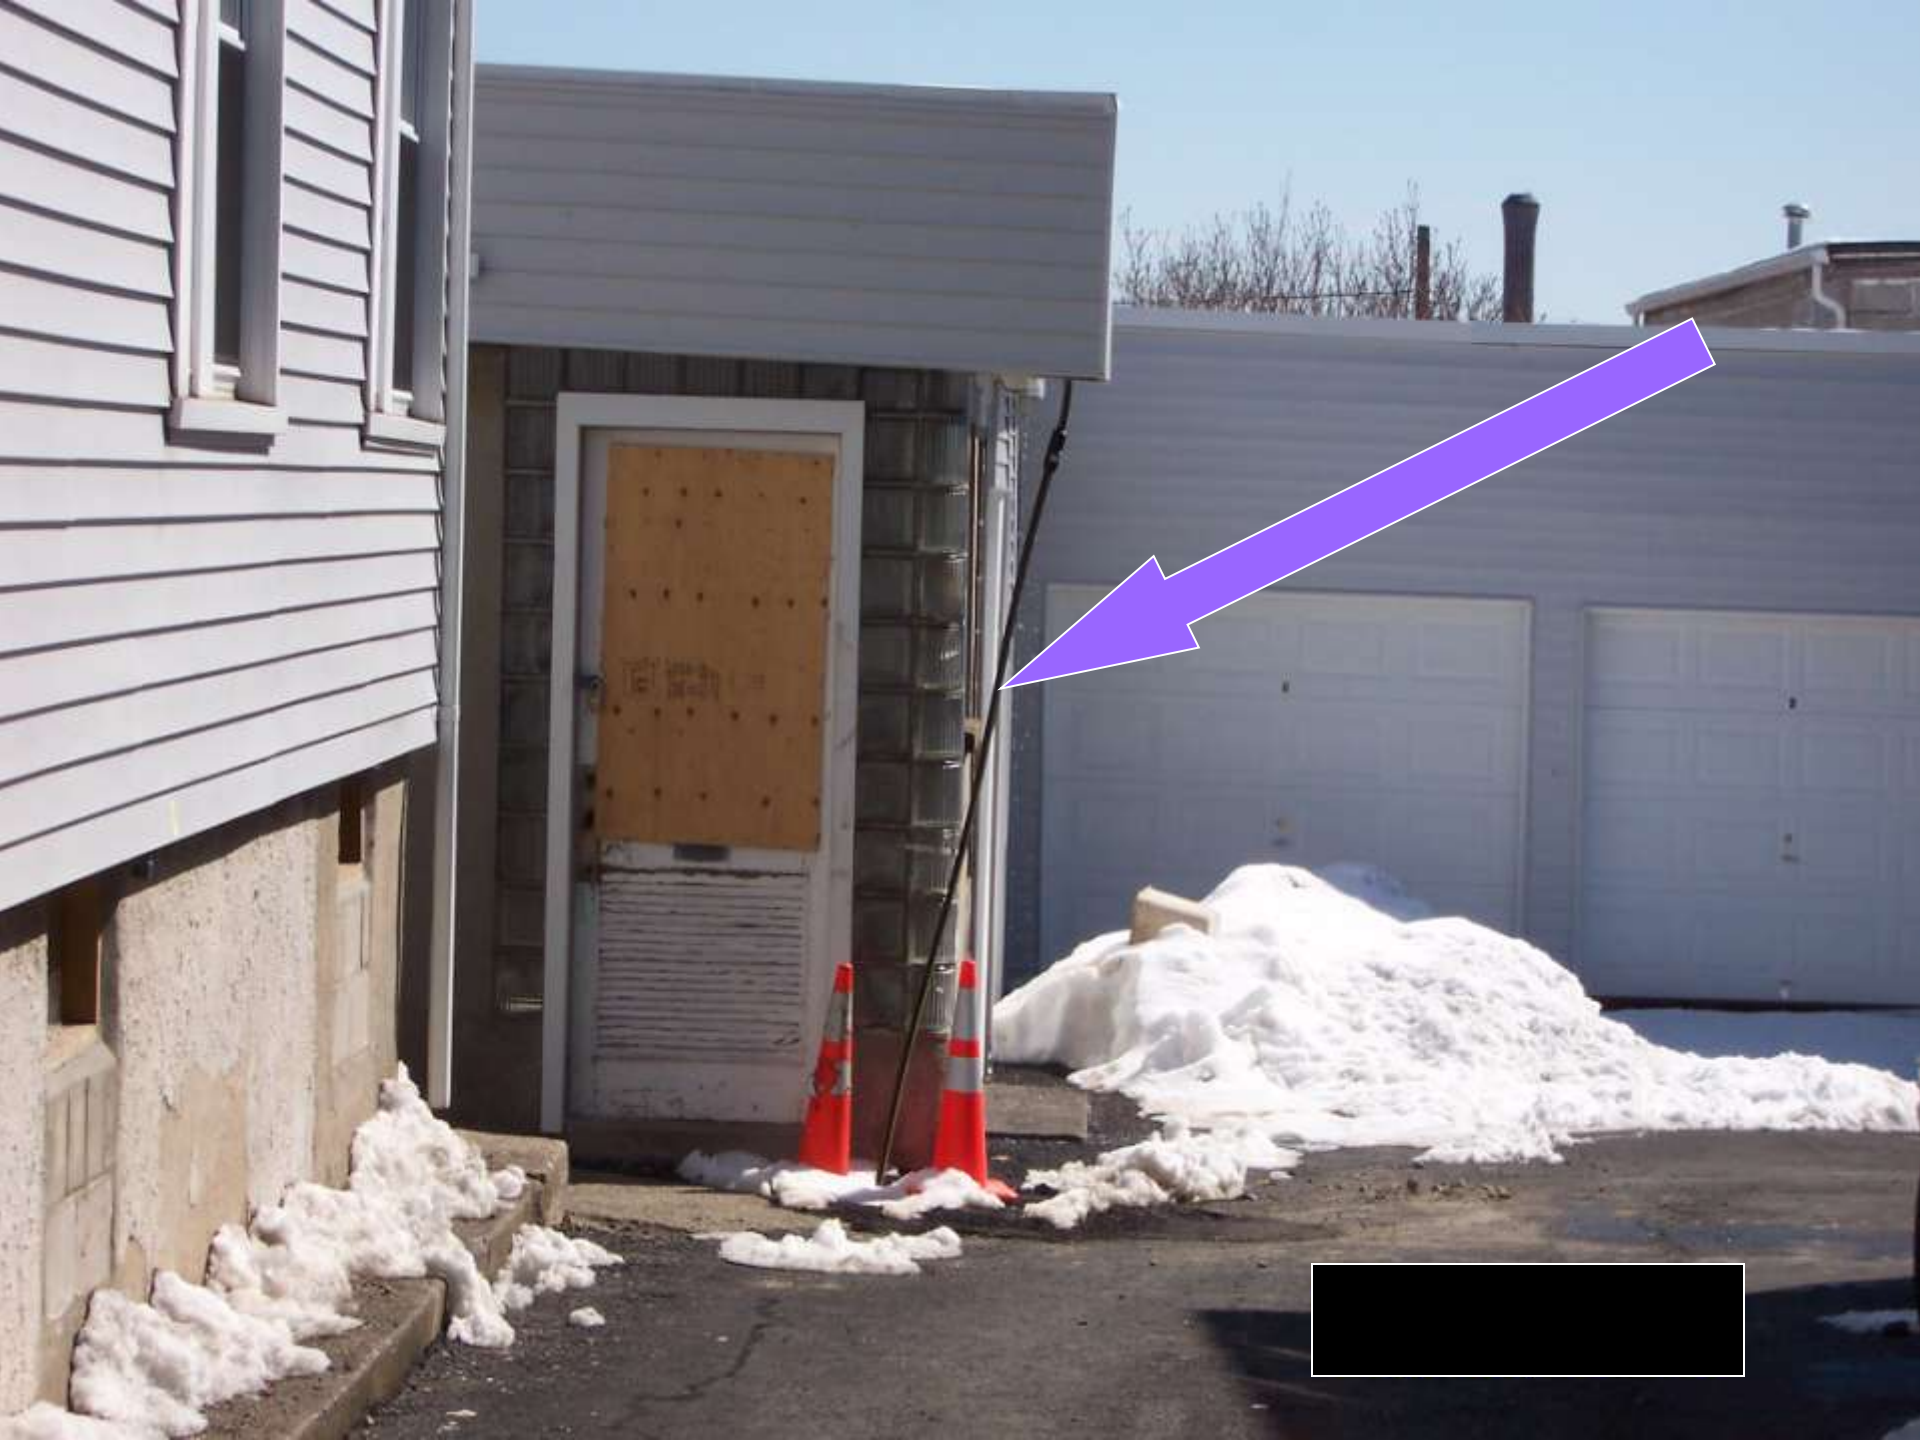
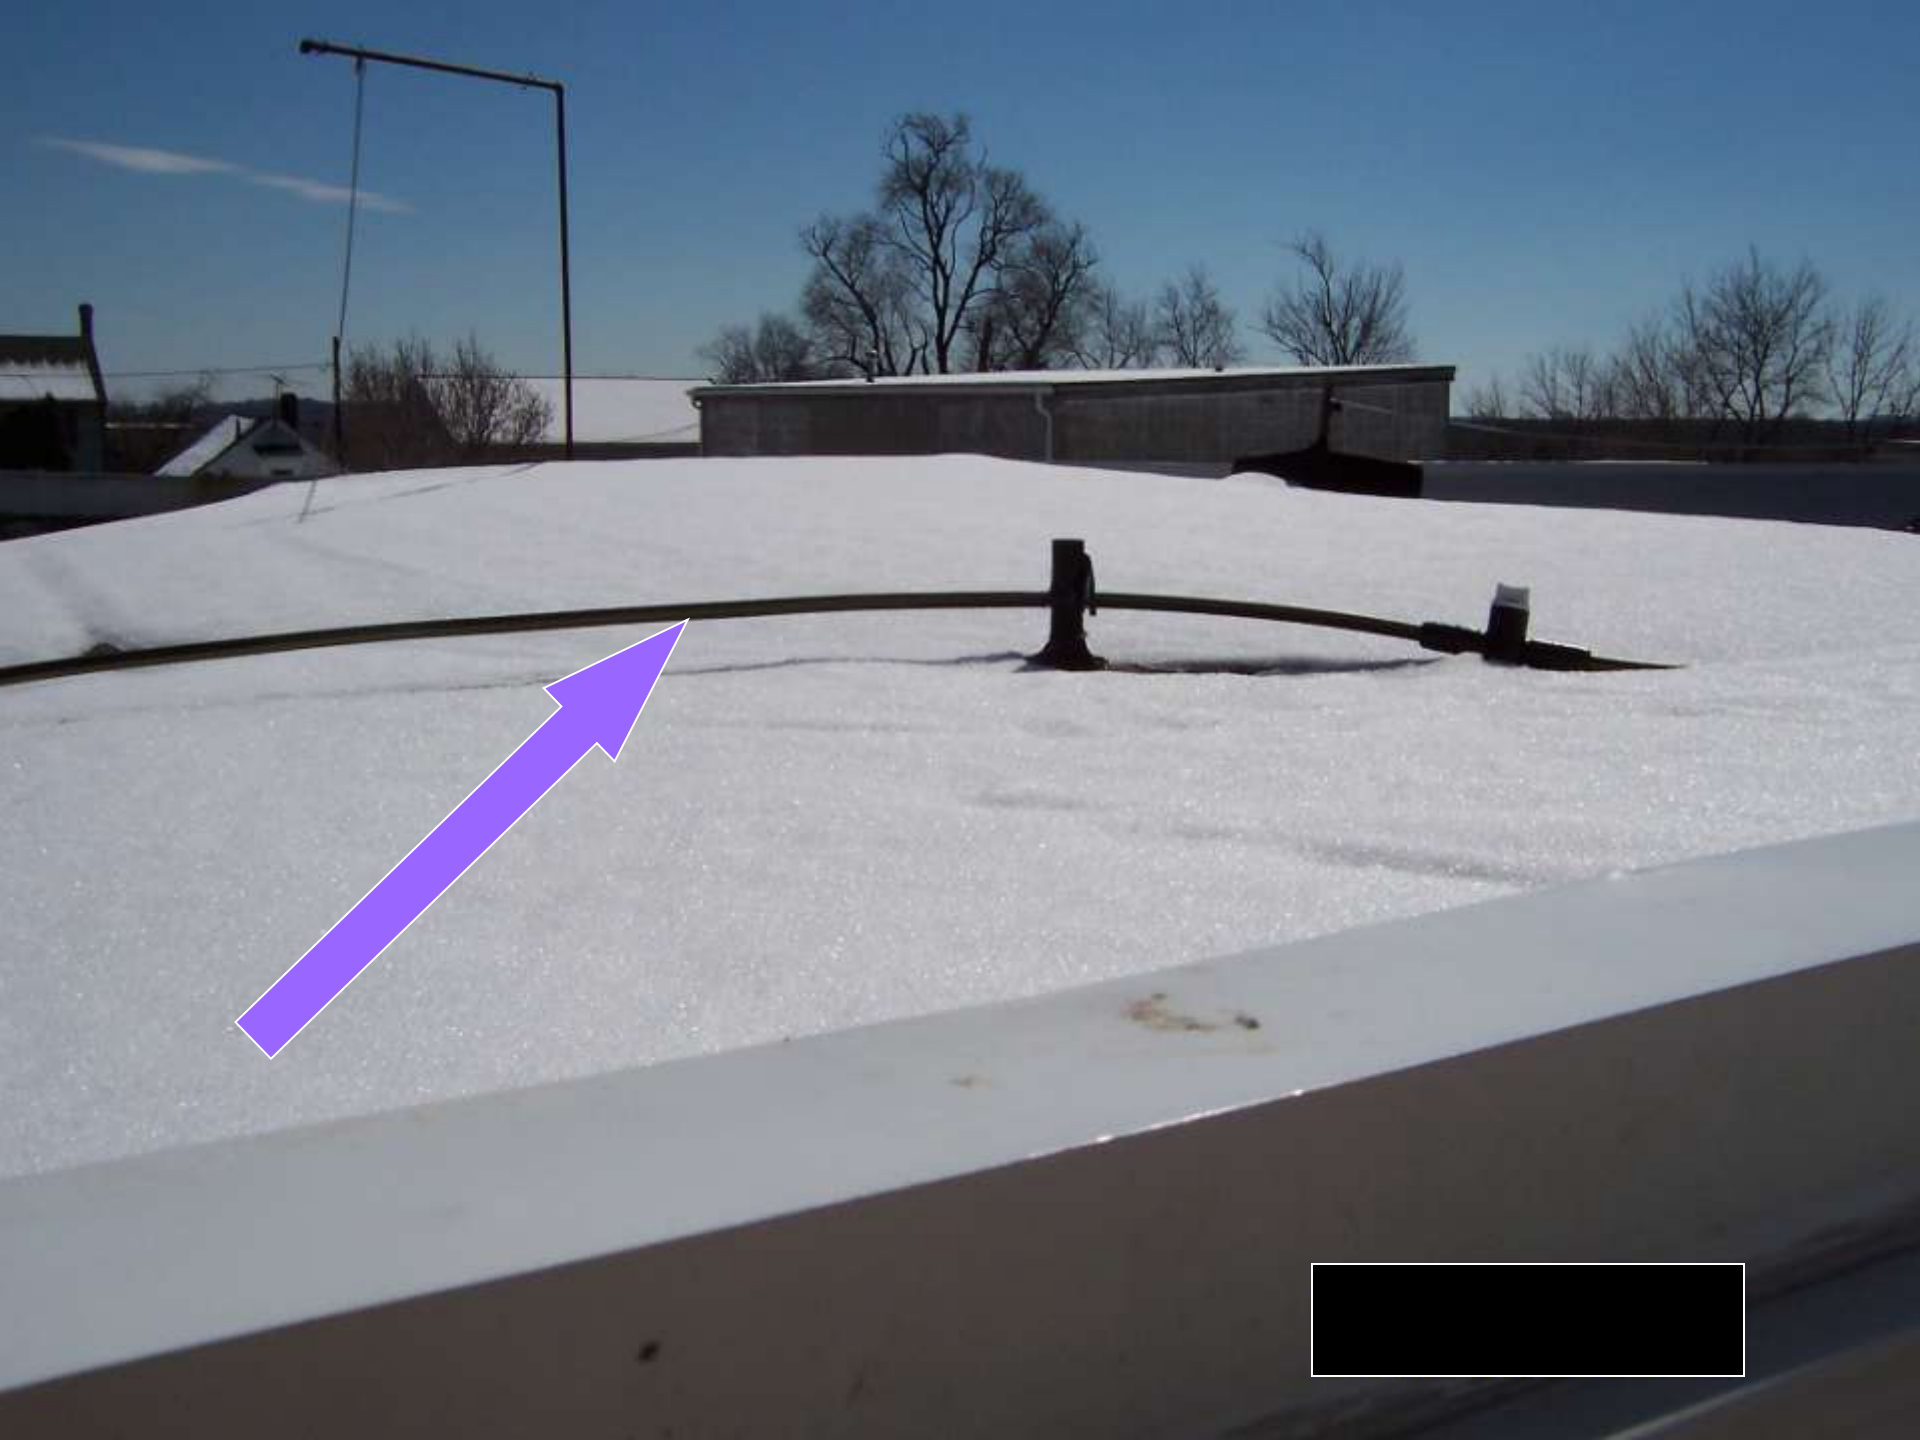
**► The Operator installed a temporary gas service above ground over a garage.**

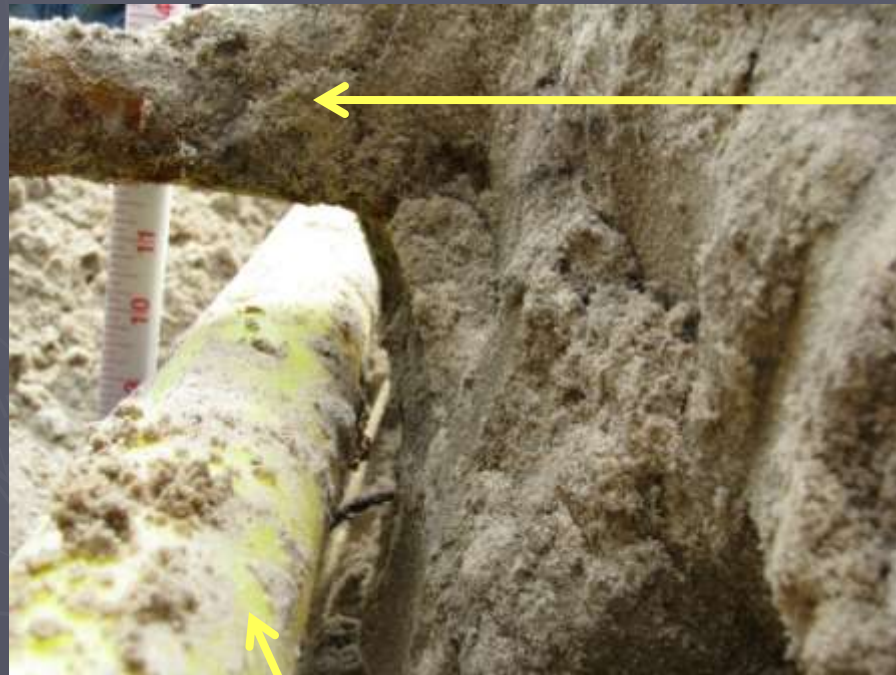
**§192.325(b) - Failure to install a main with enough clearance from any other underground structure to allow for proper maintenance**

**Electric Line**

**Sewer Line**

**2" Plastic Gas Main**

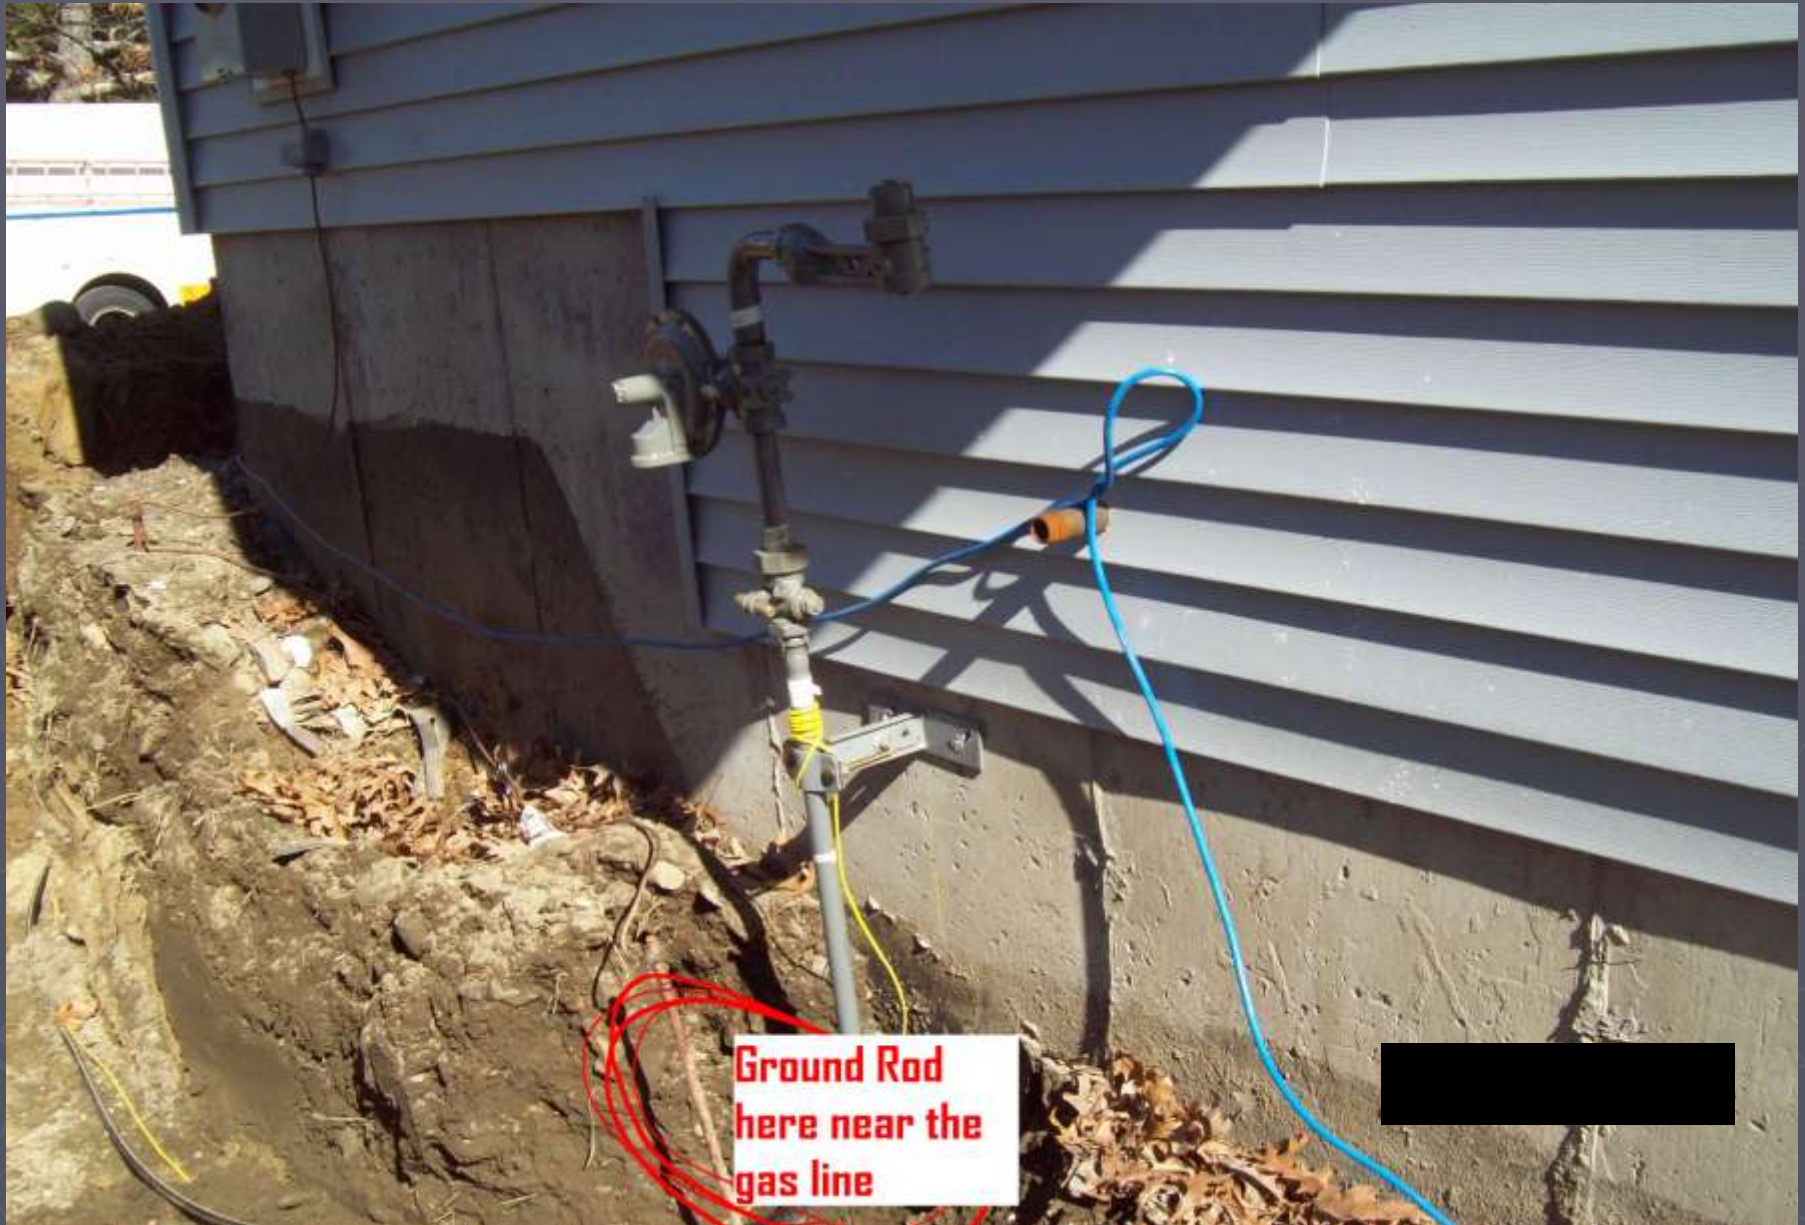
# Grounding rod right next to the service

Ground Rod  
here near the  
gas line

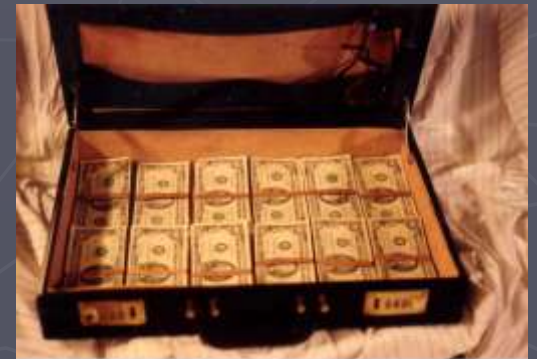
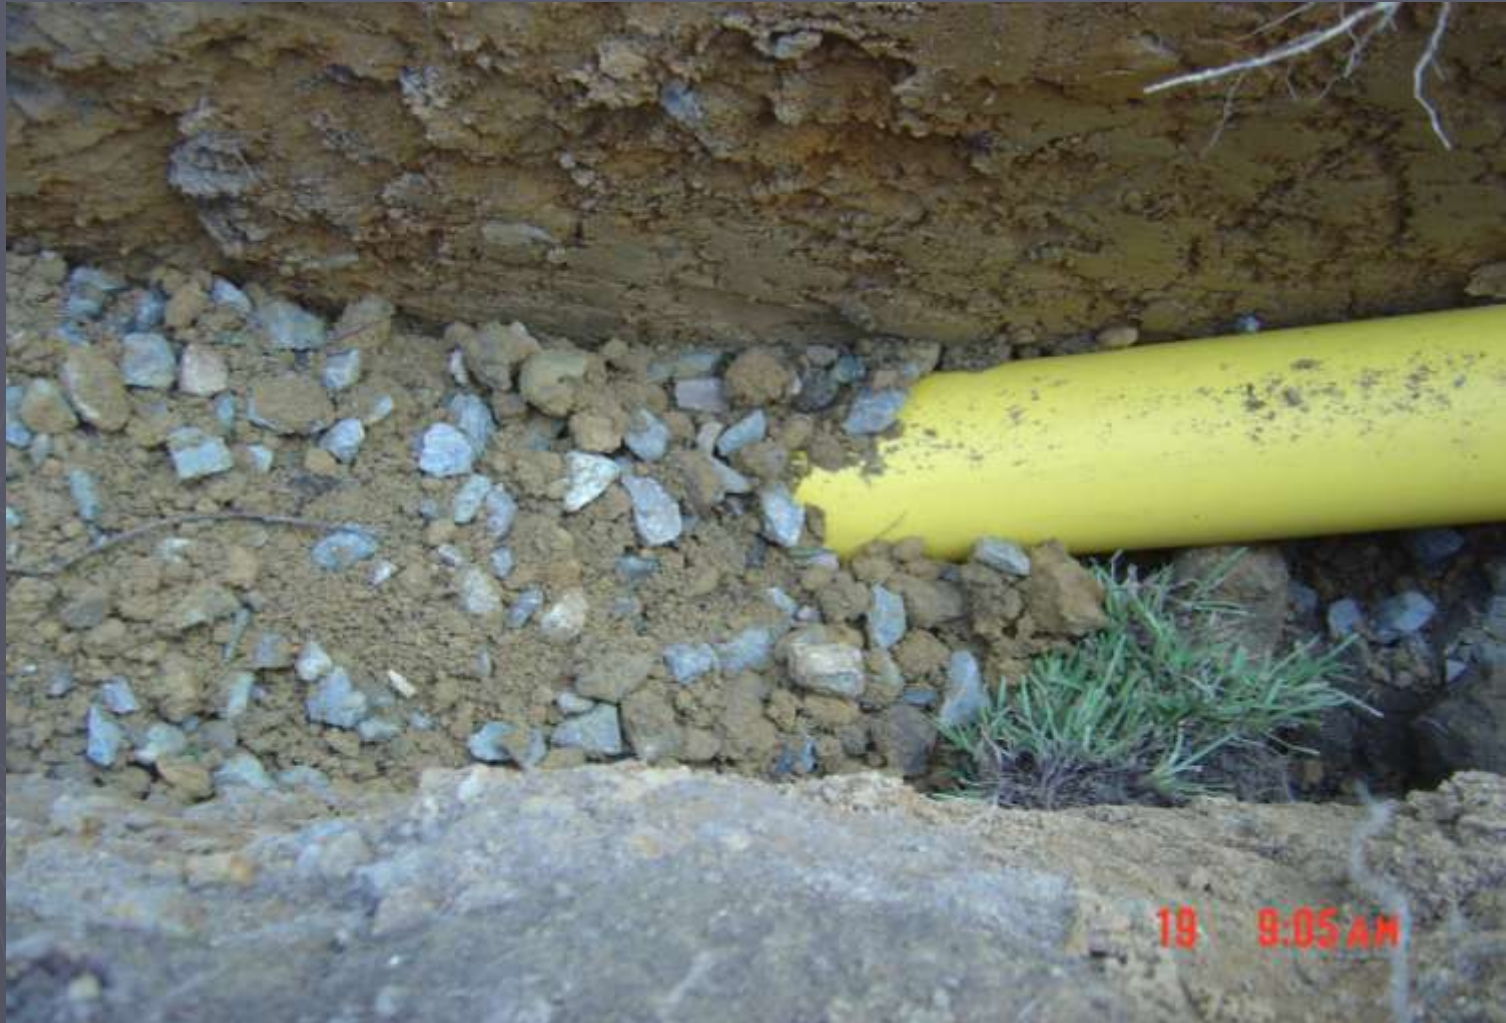
- ▶ **The Operator's contractor installed a 4" plastic main with improper backfill material. About 2500' (about a 1/2 mile) of the newly installed 4" gas main was replaced and select backfill was brought in.**

**§192.319(b)(2) - Backfill in a manner that prevents damage to the pipe from the backfill material.**

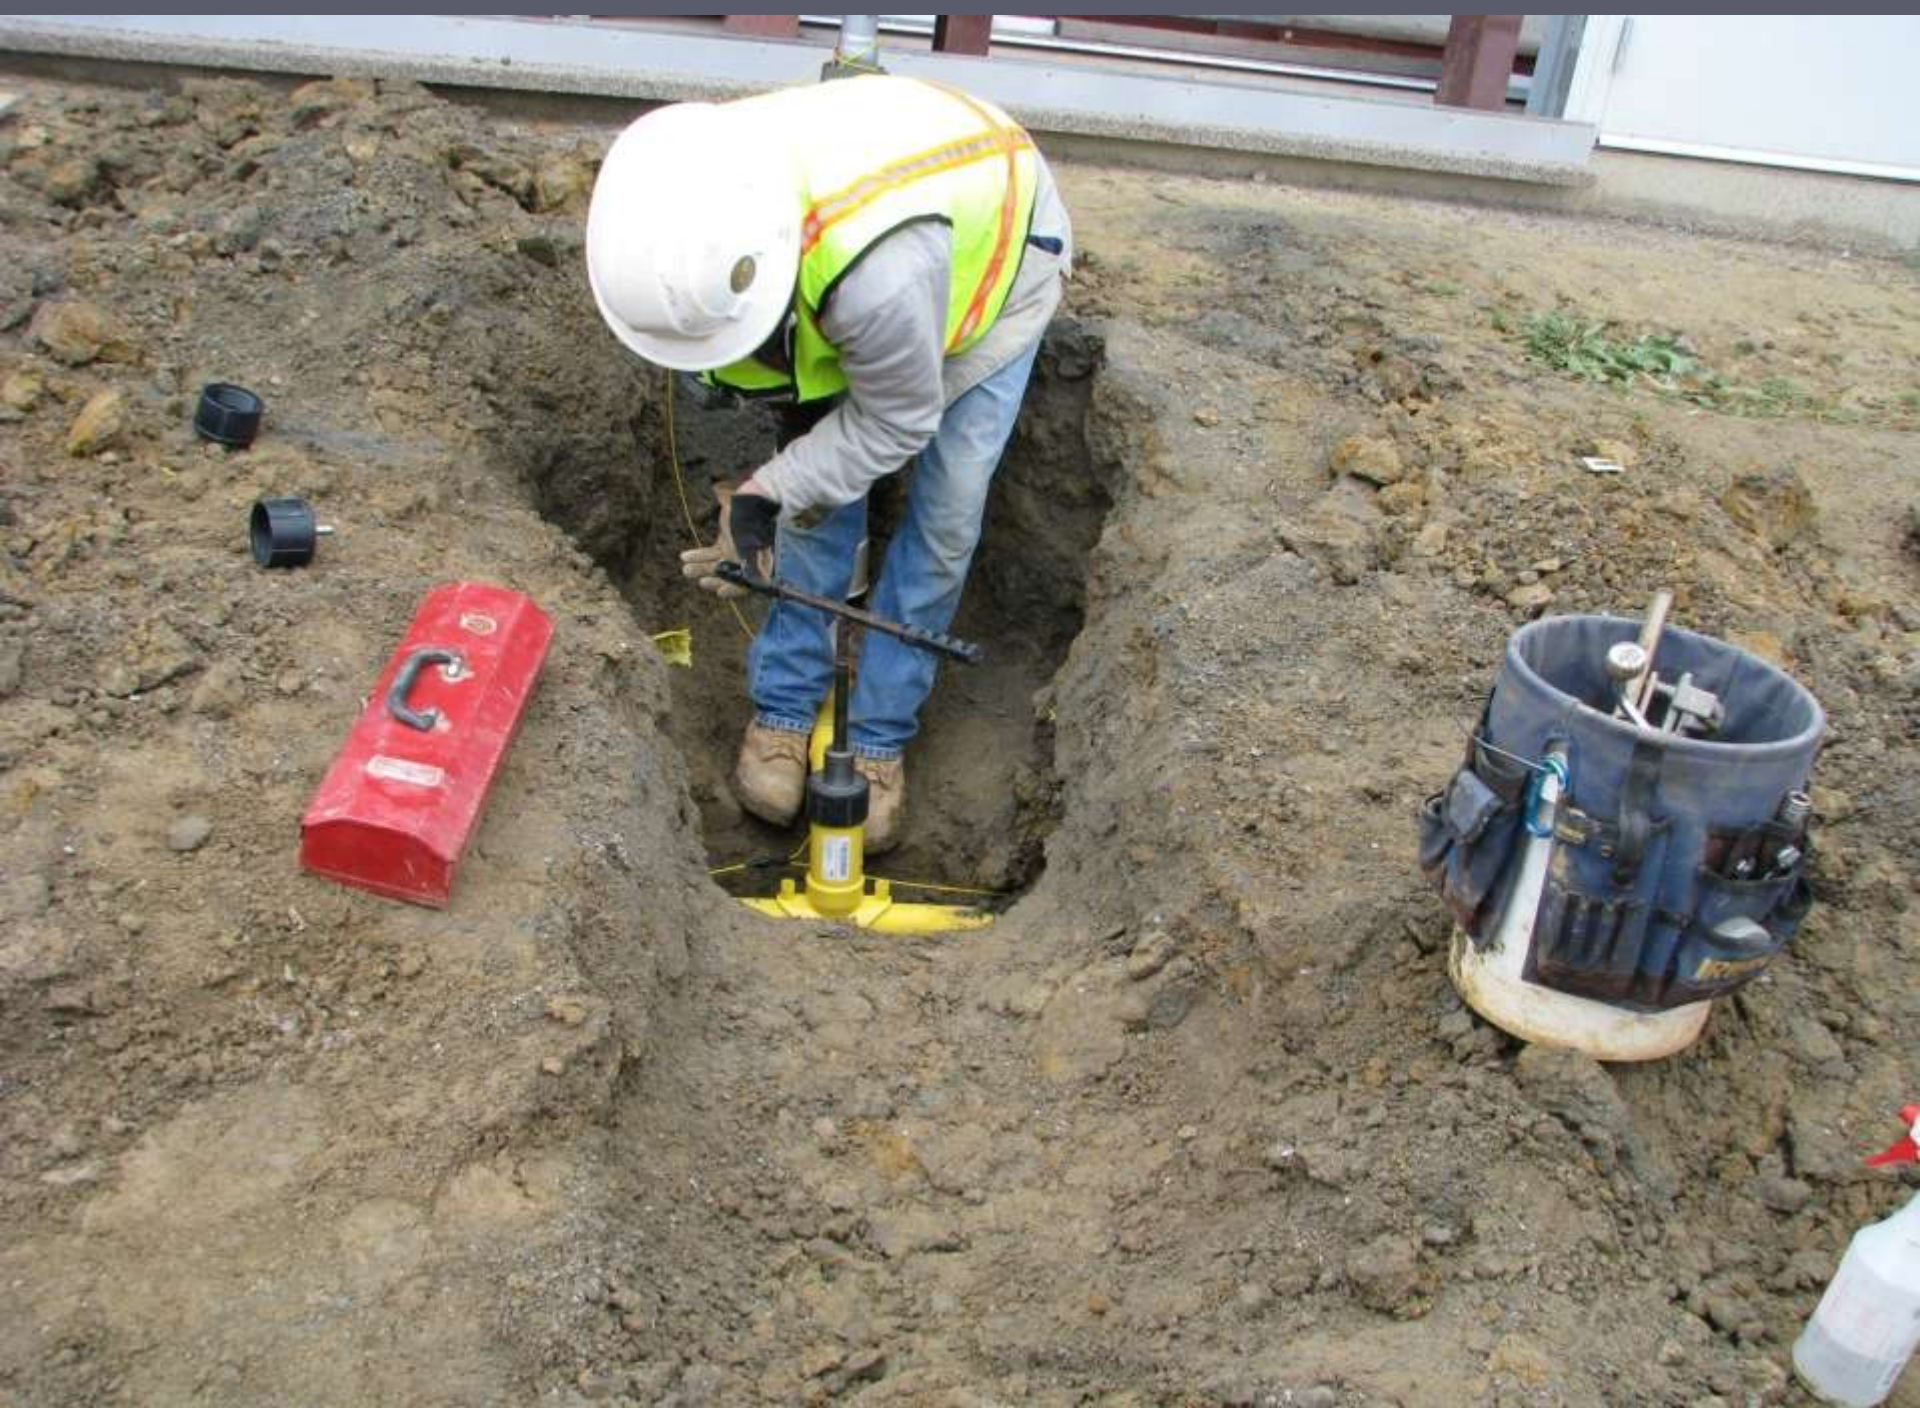
- ▶ **The Operator was performing a tapping process without properly grounding the cutting tool. A failure of the operator to follow procedures.**

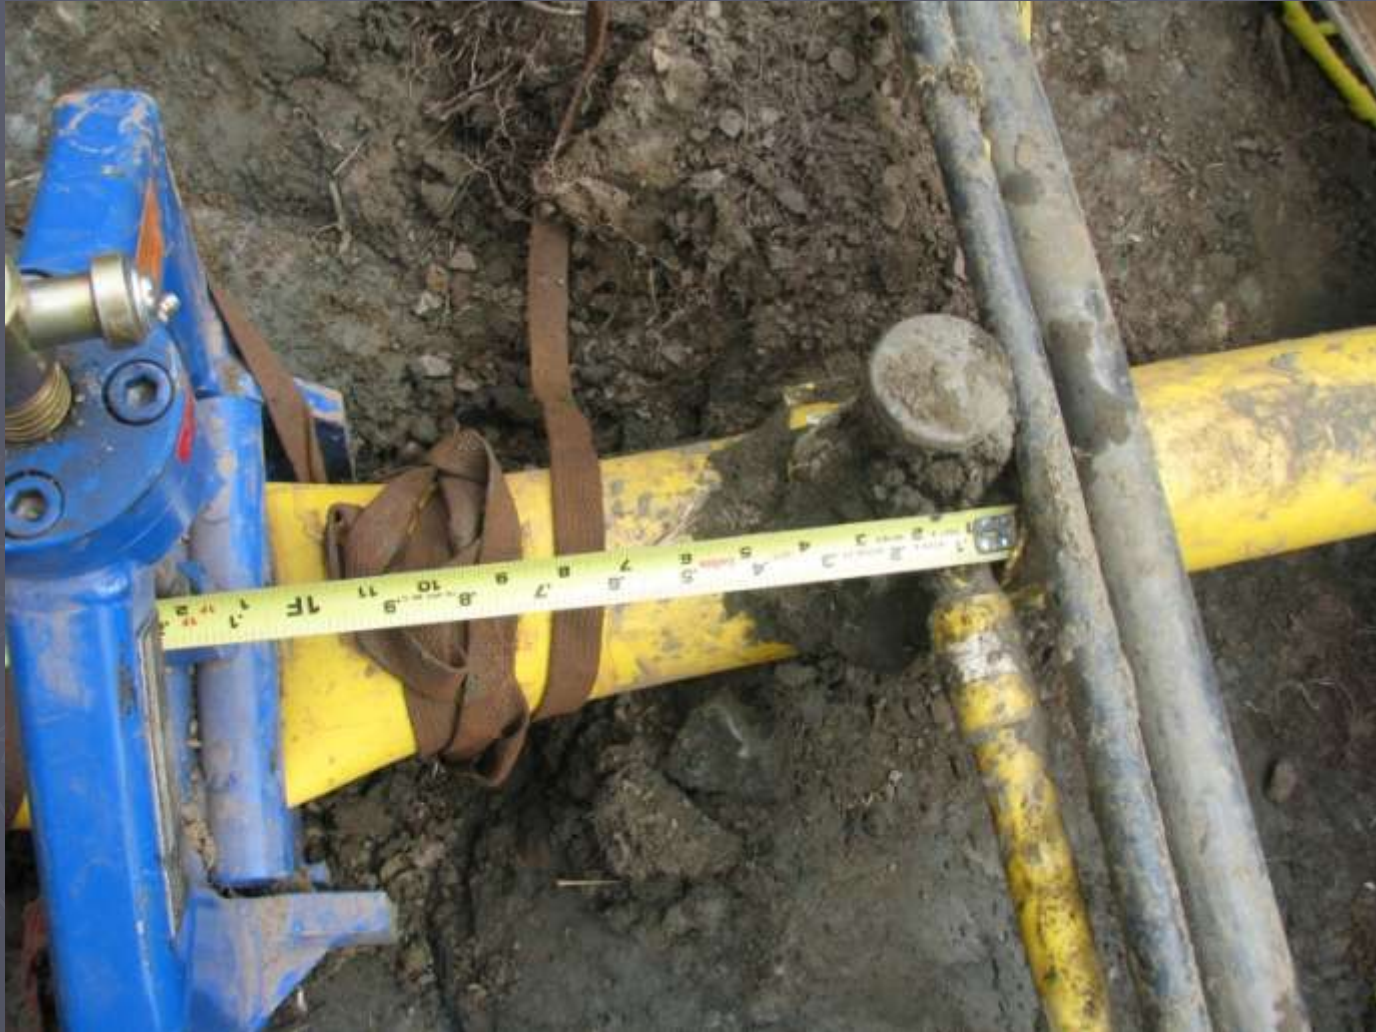
# **§192.605(b) - Failure to have adequate procedures for squeezing off a pipeline.**

- ▶ **The squeeze off tool must be at least 3 pipe diameters, or 12 inches, whichever is greater, away from any butt fusion, or any socket, saddle, or mechanical fitting.**

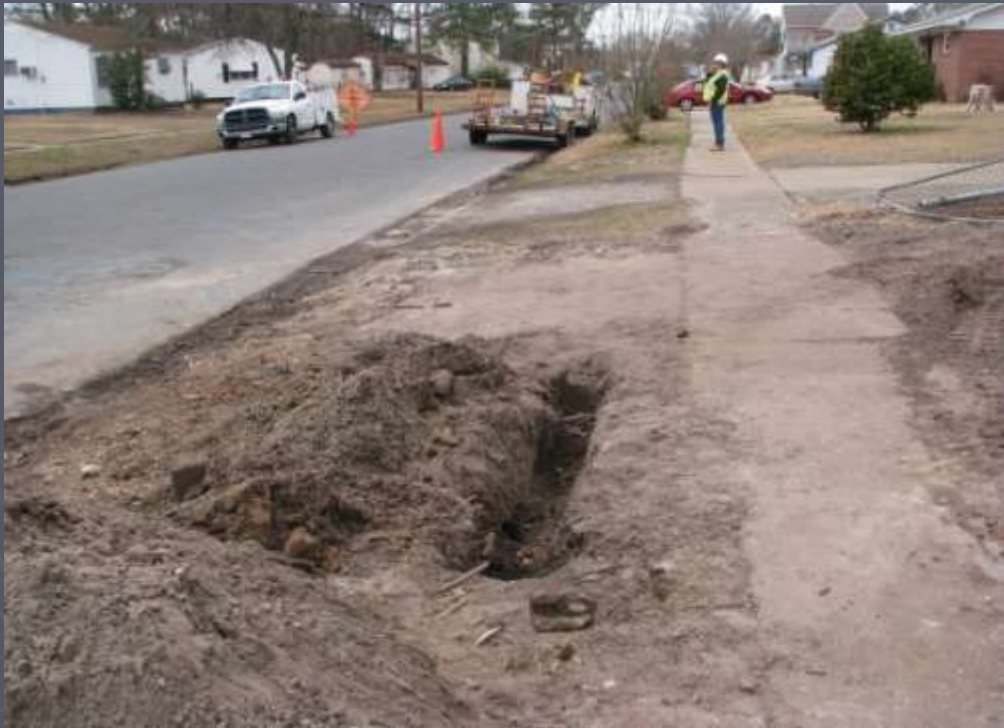
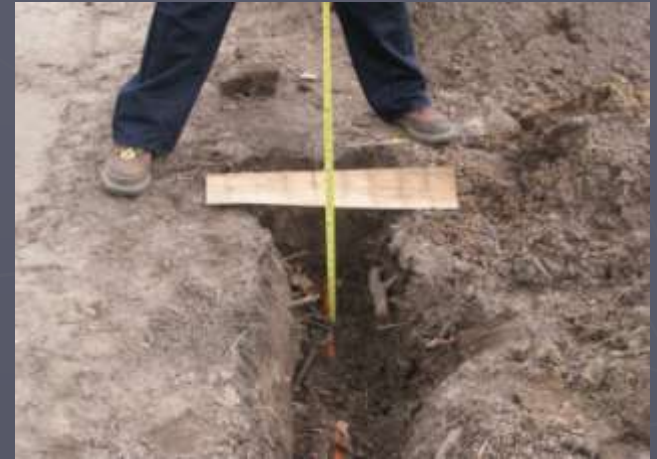
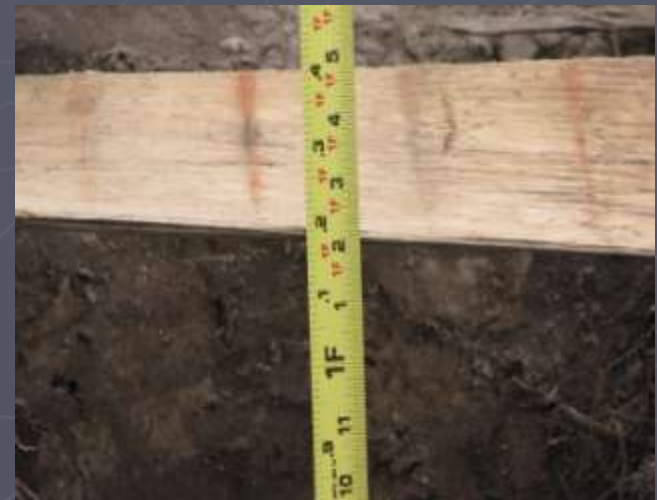
# **§192.327(b) - Failure to install a main with at least 24 inches of cover.**

**Was production a  
priority over safety?**

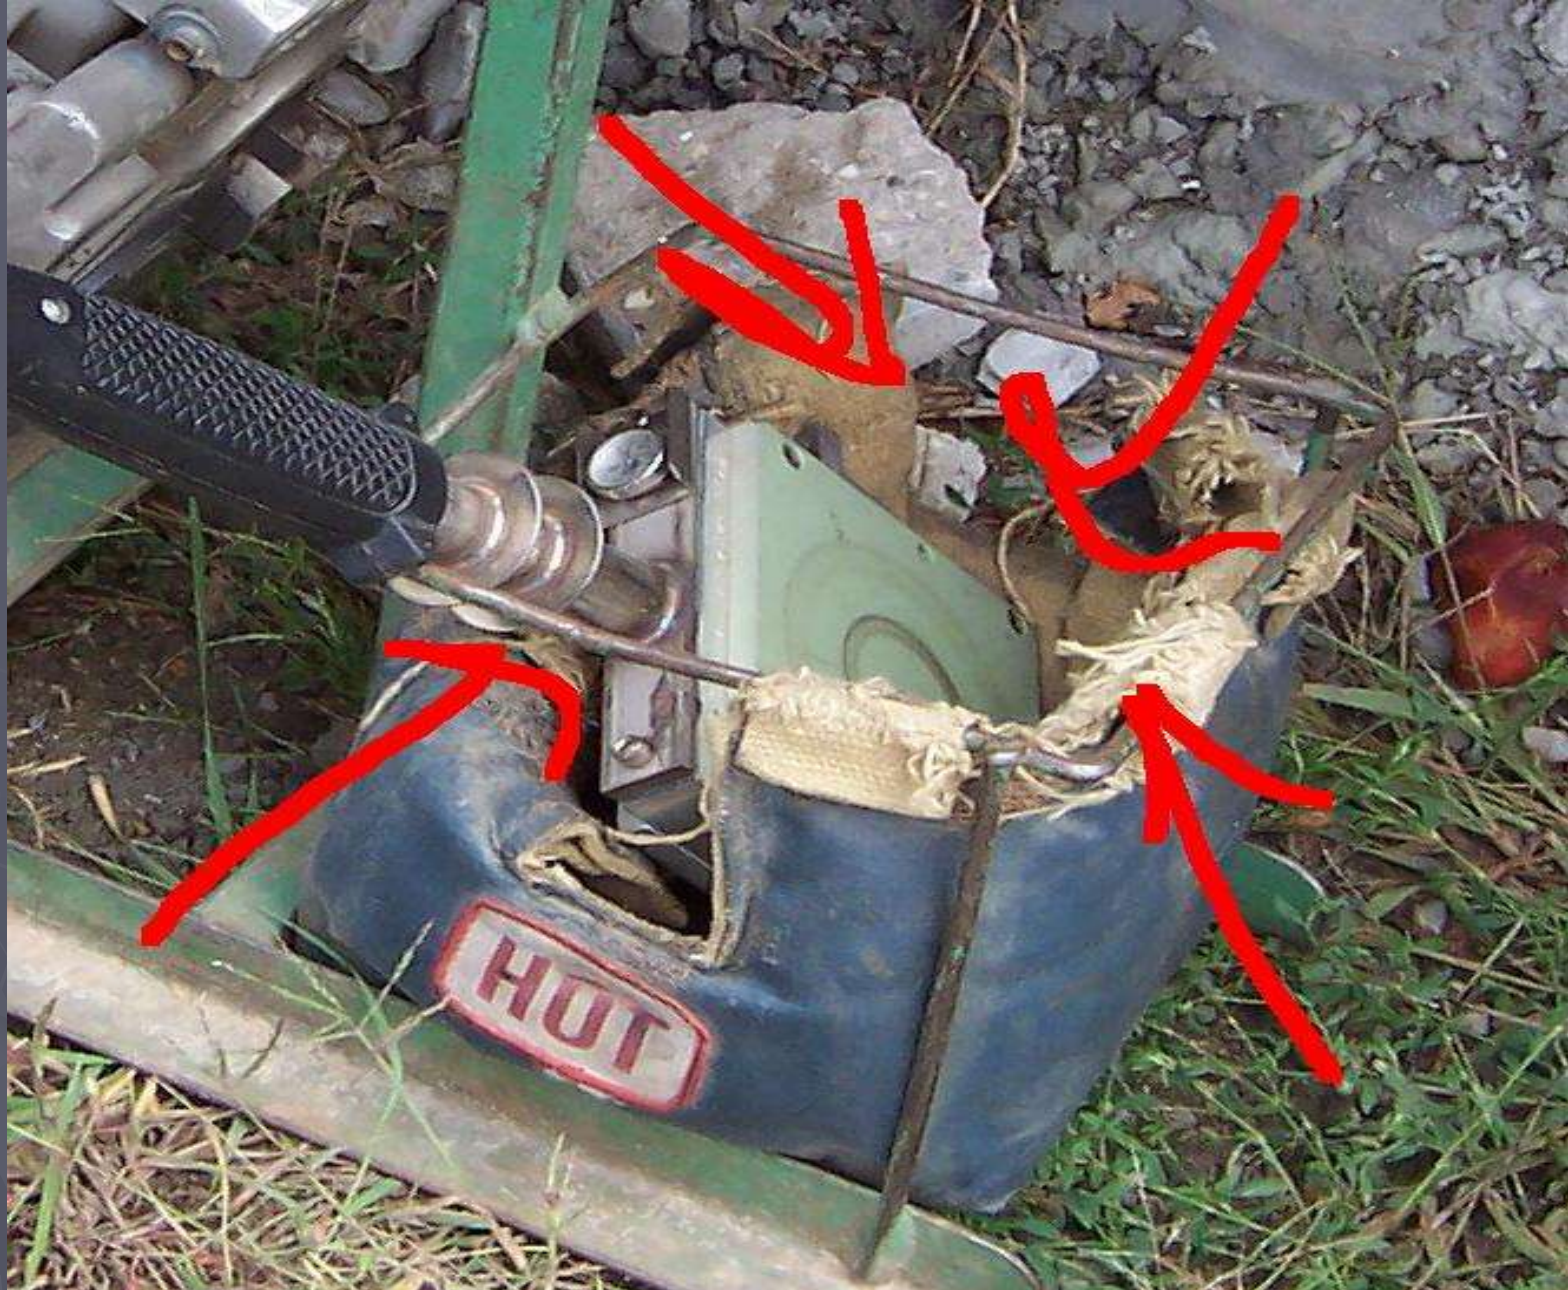
**Ripped heater bag and dirty heat plate.**

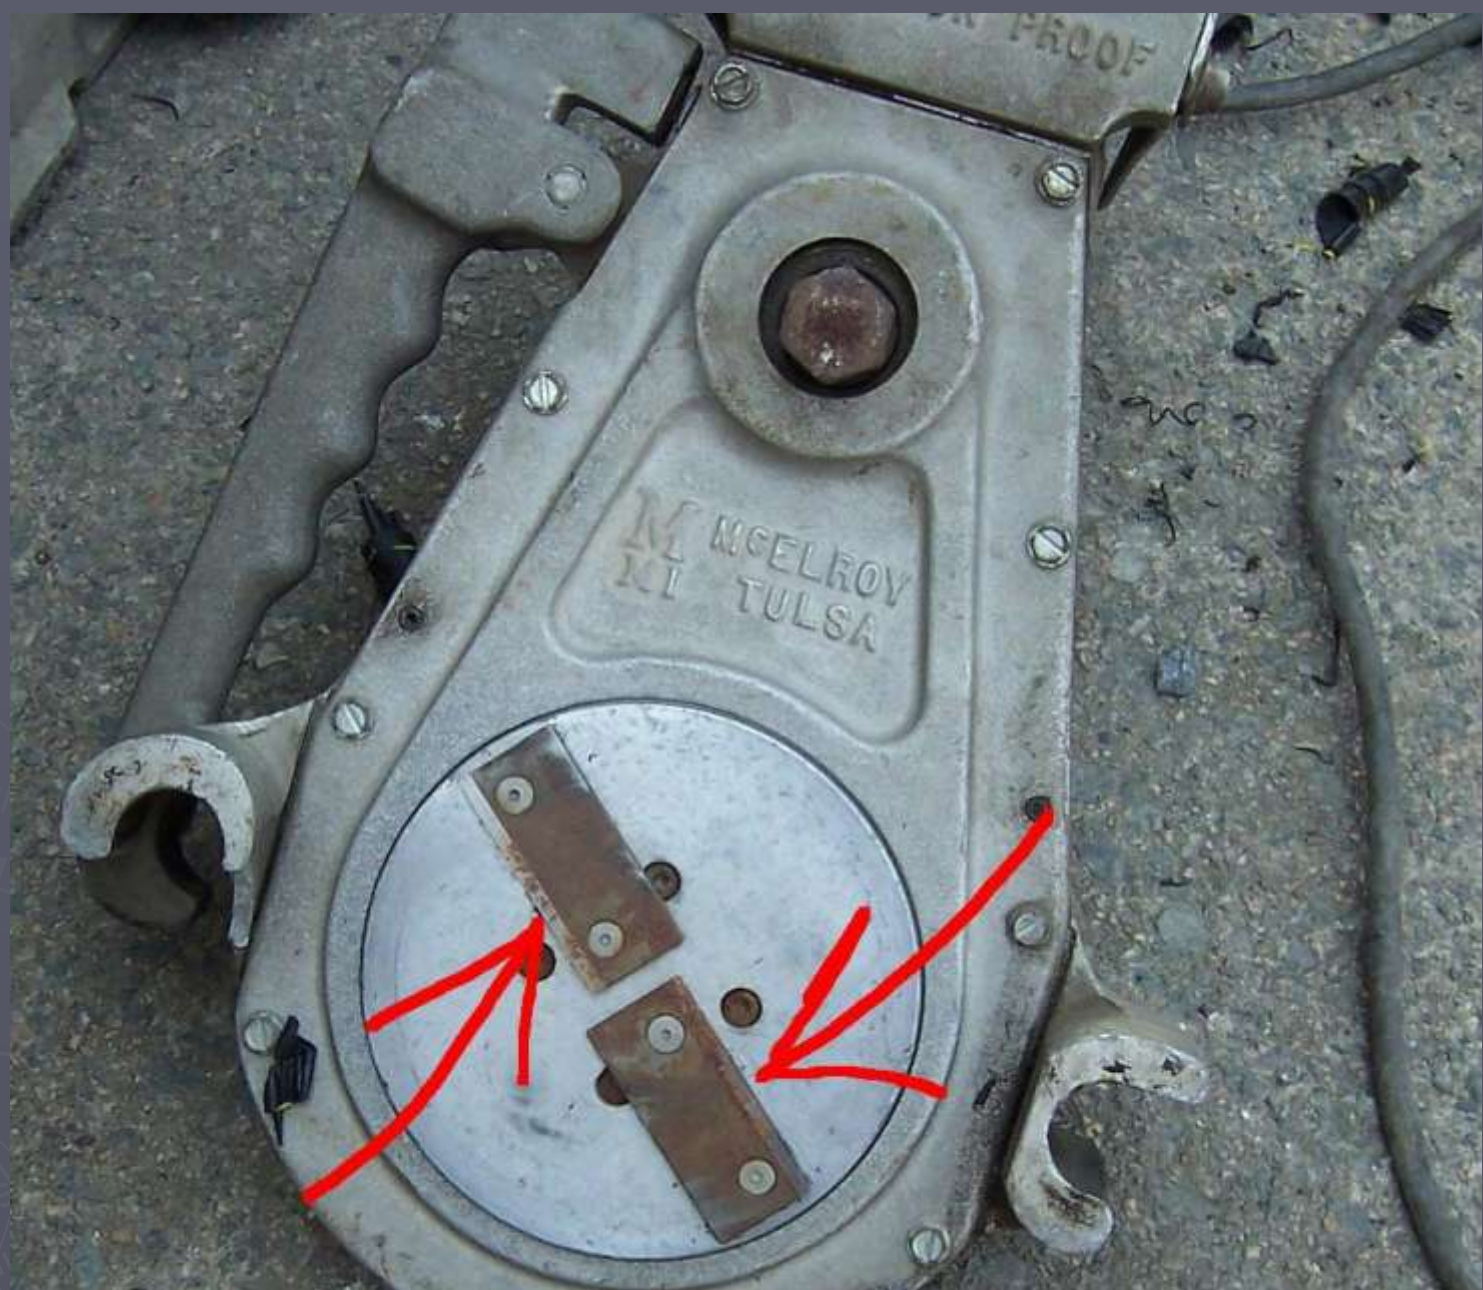
**Rusty facing blades, you're prone to failure.**
